Docket No. 217 – Development and Management Plan Inspection

Northeast Utilities Service Company Certificate of Environmental Compatibility and Public Need for the construction of a 345-kV electric transmission line and reconstruction of an existing 115-kV electric transmission line between Connecticut Light and Power Company's Plumtree Substation in Bethel, through the towns of Redding, Weston, and Wilton, and to the Norwalk Substation in Norwalk, Connecticut.

Date: August 10, 2005

Location: Norwalk Substation Expansion

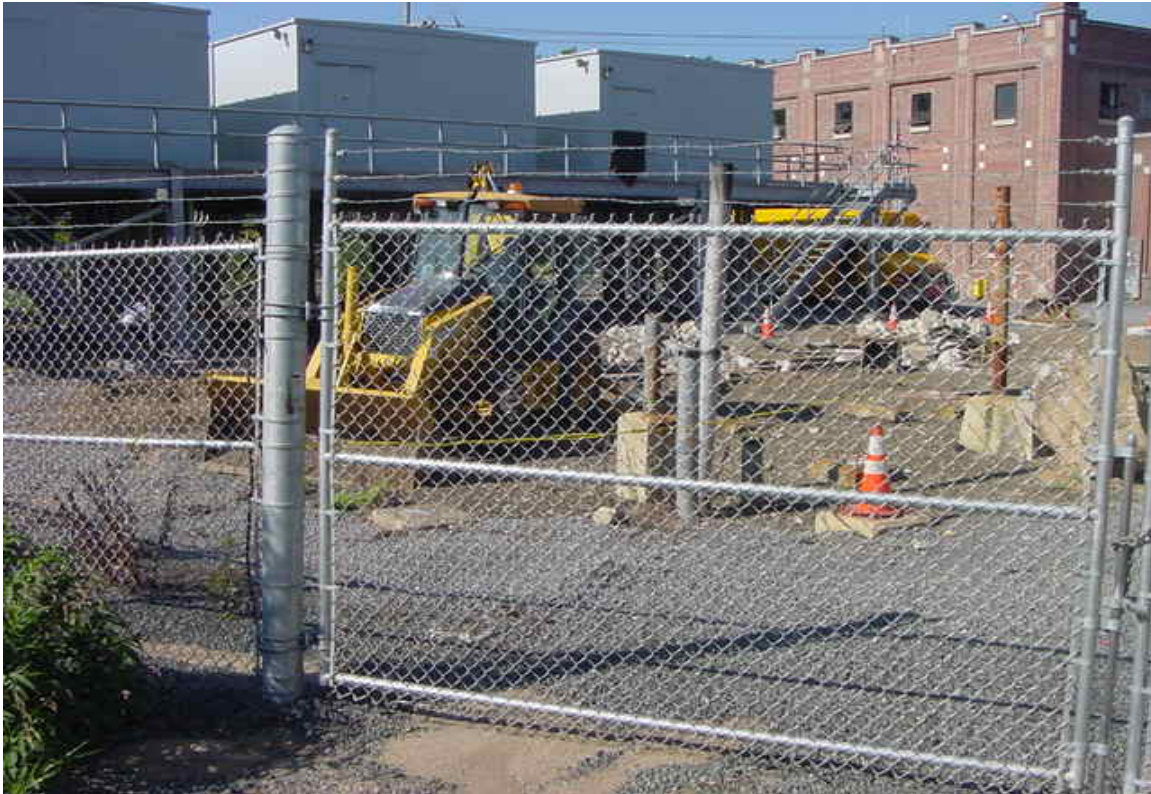
Norwalk Substation: Minor excavation and breaking up and removal of concrete continues within the live yard. (8/10/05)

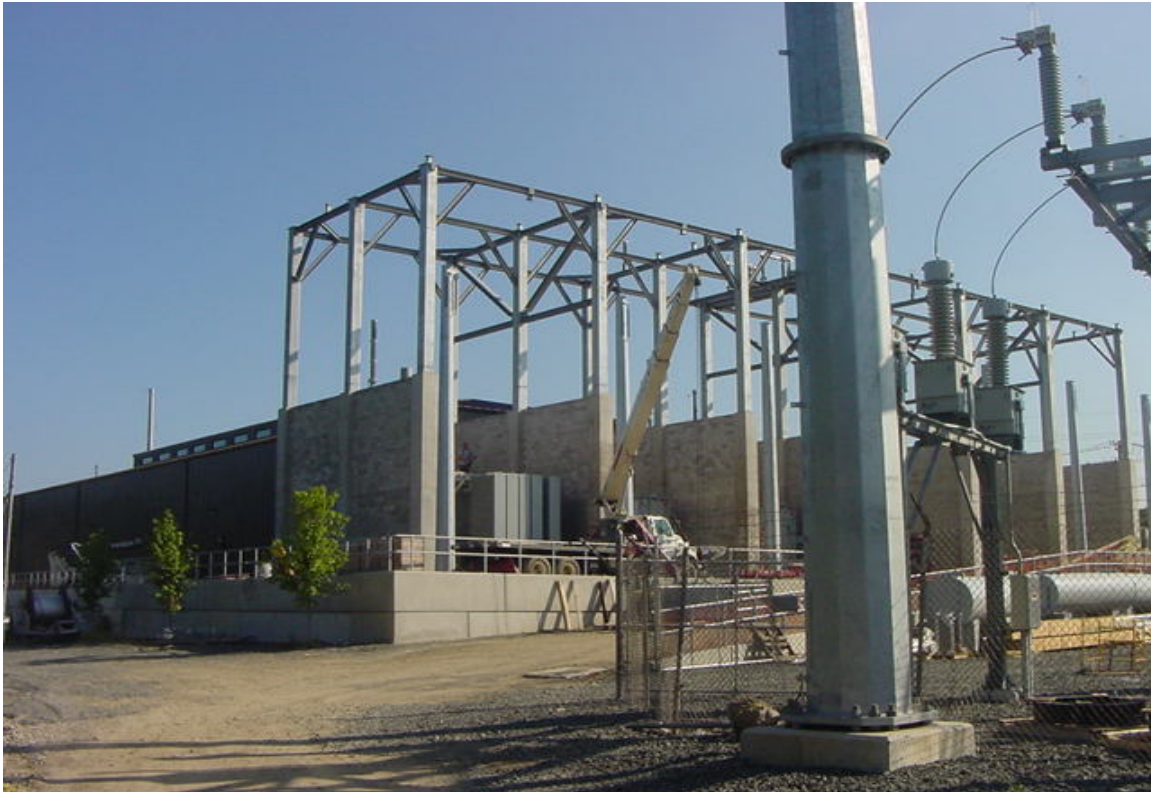
Transformer work continues in the GIS building area. (8/10/05)

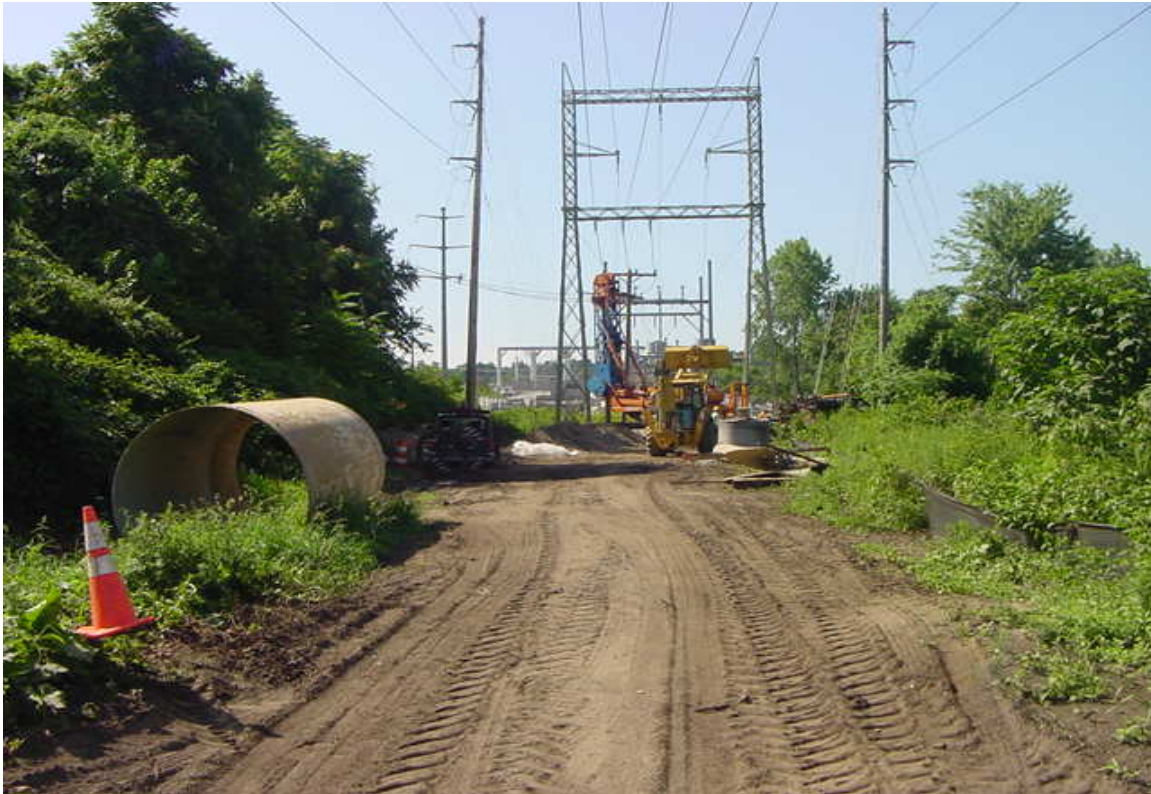
Additional Observations	<ul style="list-style-type: none"> - Work immediately adjacent to the substation fence in the ROW has some silt fence issues. Materials are being placed on or beyond the fence here. This will also be noted in the 115kv report but the contractor working in the area should repair the erosion control. 8/10/05 	<ul style="list-style-type: none"> -Determine ownership of the area and repair the erosion control. 8/10/05

View of the ROW near the edge of the Norwalk Substation. Erosion control in this area requires some attention but this may be a responsibility of the 115kV project. (8/10/05)

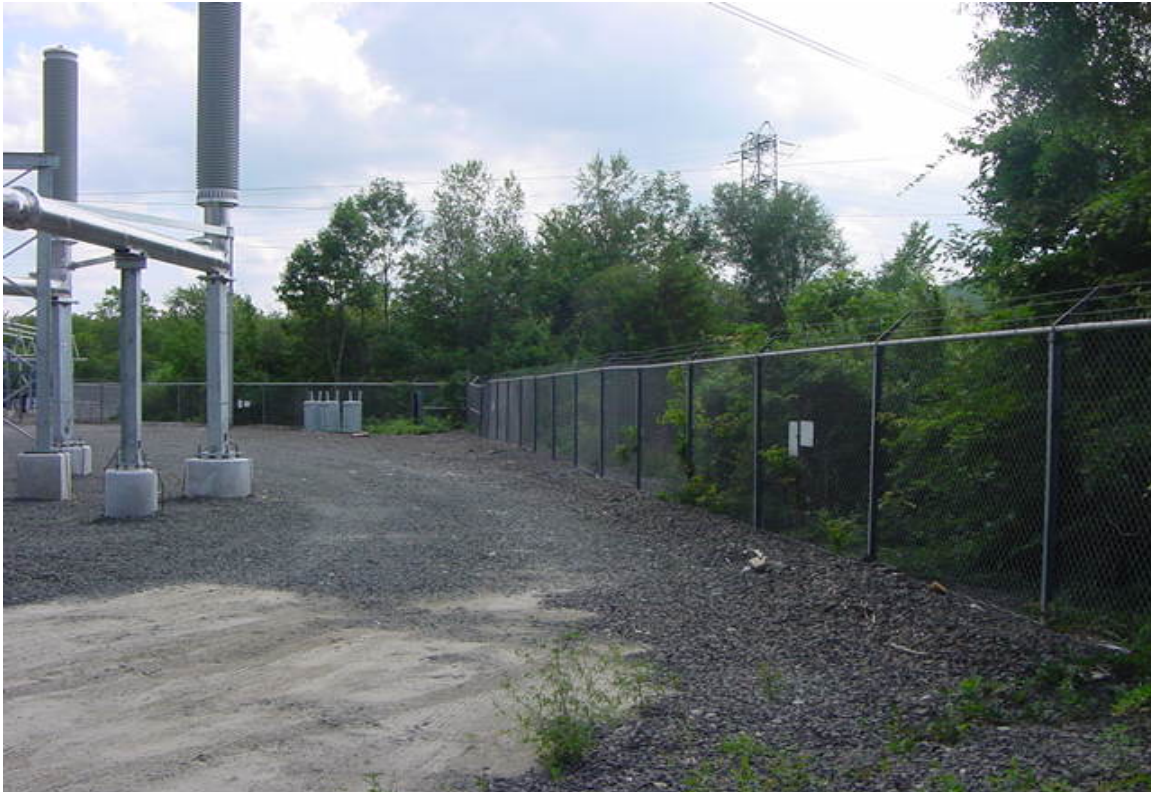
Plumtree Substation: The perimeter berm continues to keep sedimentation from occurring offsite. (8/10/05)
